## CASE STUDY

### Corrosion mitigation and improved turbine protection in Jönköping Energy AB Biomass Power Plant

##### Jönköping Energy AB – Sweden

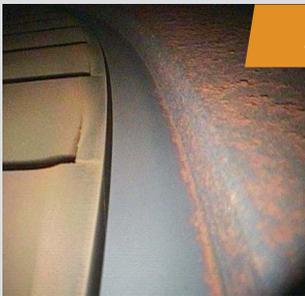
Corrosion damages, off-line corrosion scale formation

Increased corrosion damage (downtime periods)

- SIEMENS' video endoscopy showed cleaner surfaces with no corrosion signs.
- Flow accelerated corrosion (FAC) and off-line corrosion mitigated, enhancing turbine component longevity.

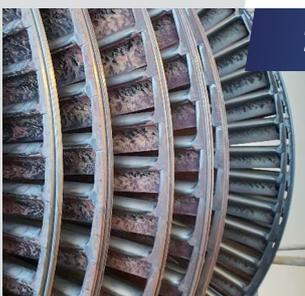
2021

After ODACON® dosing: Shining surfaces, no signs of further corrosion, less deposits

- Preservation plan effectively reduced turbine deposits.
- Prevention of scale formation from boiler carry-over.
- Smoother turbine operation and increased efficiency.
